WA-II-495 Frame House

Benevola Vicinity

State Historic Sites Inventory Form

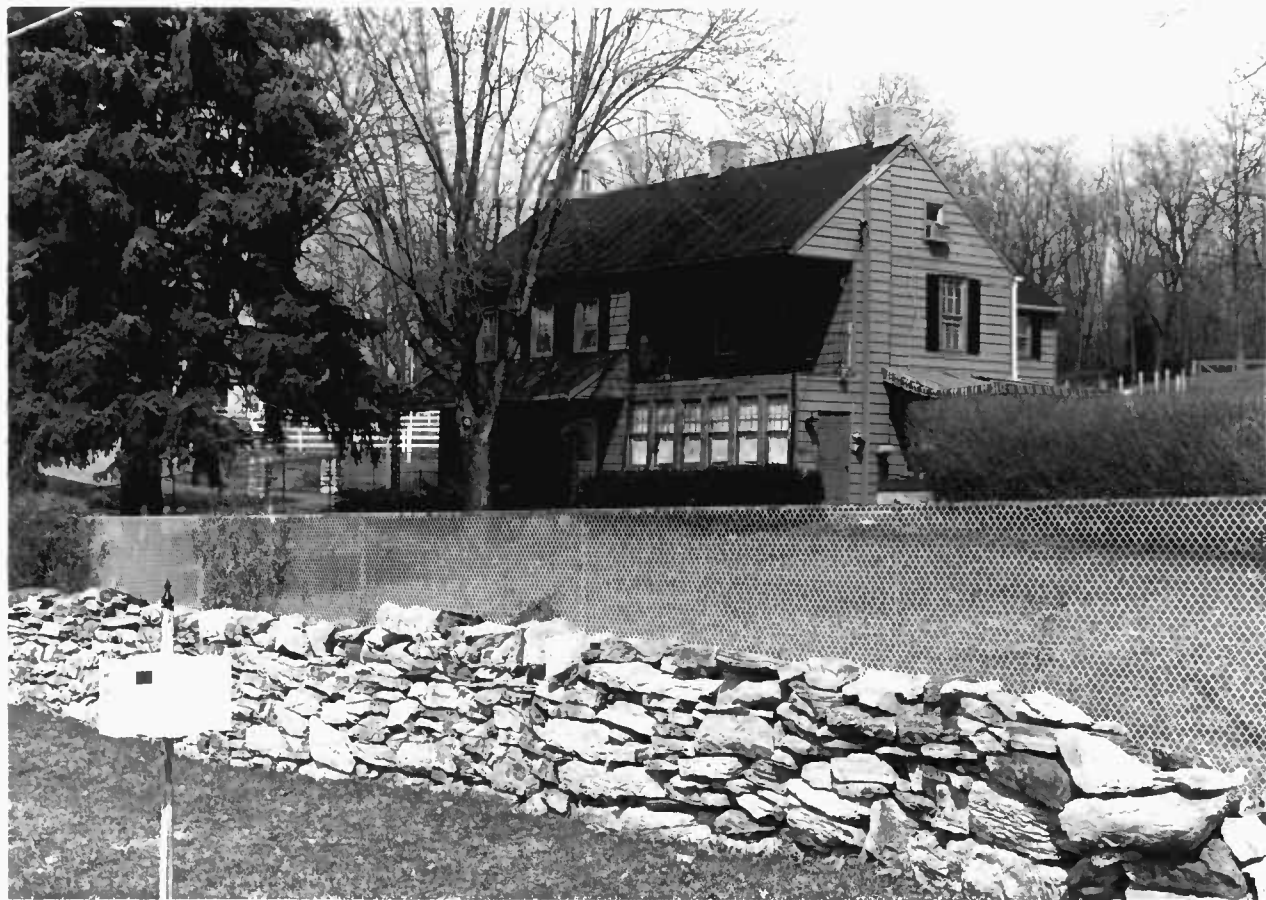
1. Frame House WA-II-495
2. Washington County, Maryland
3. Joe Getty
4. May 1981
5. Maryland Hist. Trust, Annapolis, Md.
6. West & south elevations; camera facing
northeast
7. 1/1
